**Dixon Sand
Old Northern Road Quarry, Maroota**

**Addendum
Annual Review
2019 – 2020**

Client: Dixon Sand Pty Ltd

Prepared by: Project Environmental Services Pty Ltd

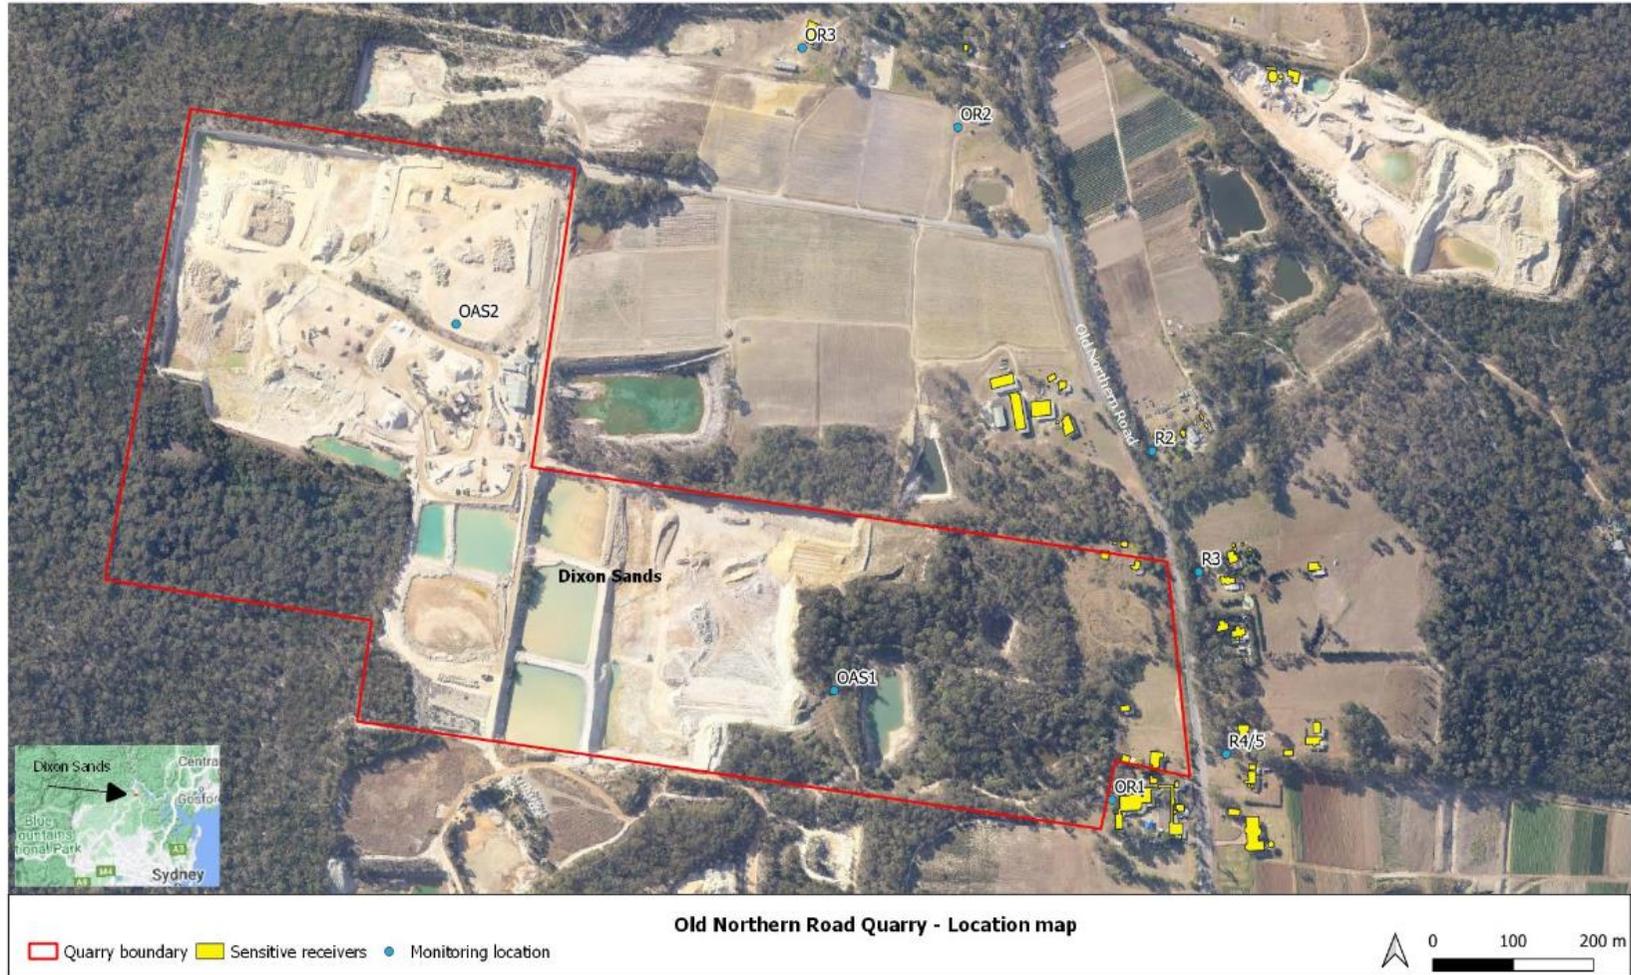
Figure 1: Noise Monitoring Locations at receivers (courtesy of Hutchison Weller, 2020).

Figure 1 depicts the locations of the attended noise monitoring locations at Maroota Public School (OR1) and other receivers (R2, R3, R4, R5, OR2 and OR3).

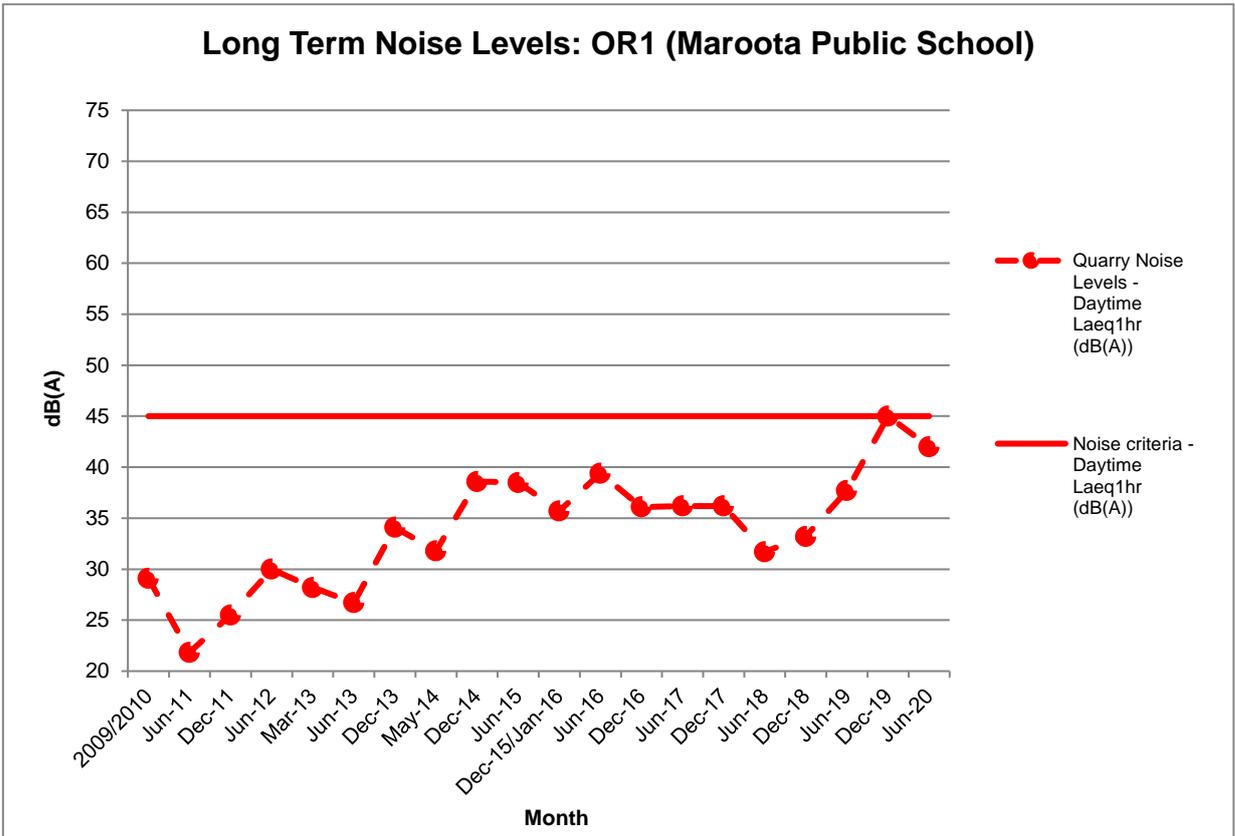
Chart 1 - Long term Noise Trend – Maroota Public School

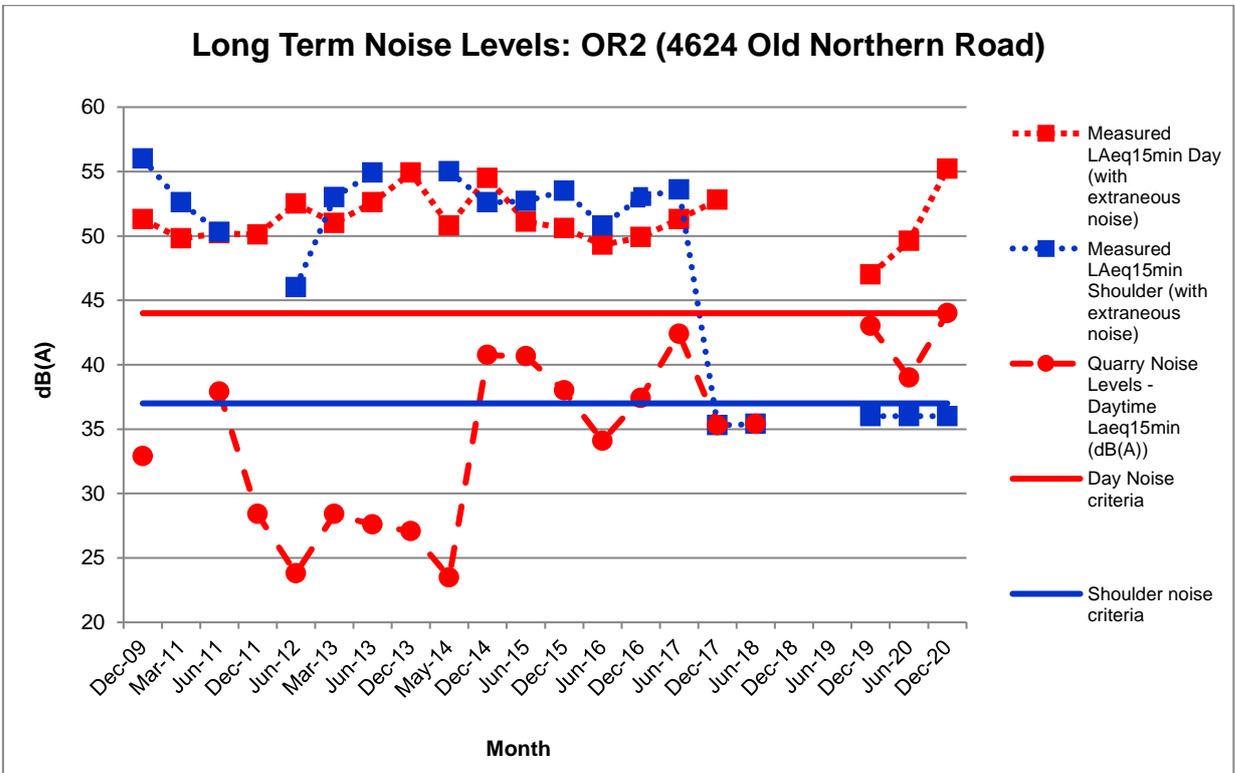
Chart 2 - Long term Noise Trend – OR2 (No. 4624 Old Northern Road)

Chart 2 provides long-term data for receiver OR2 at 4624 Old Northern Road. Fluctuations in daytime and shoulder noise levels can be observed where reduced daytime noise levels were recorded between December 2011 to May 2014, possibly a consequence of reduced quarry activities on Lots 29 and 196. From December 2014 to date, a general increasing daytime noise levels trend can be observed, with noise levels ranging from $L_{Aeq15min}$ 34.1 to 44 dB(A).

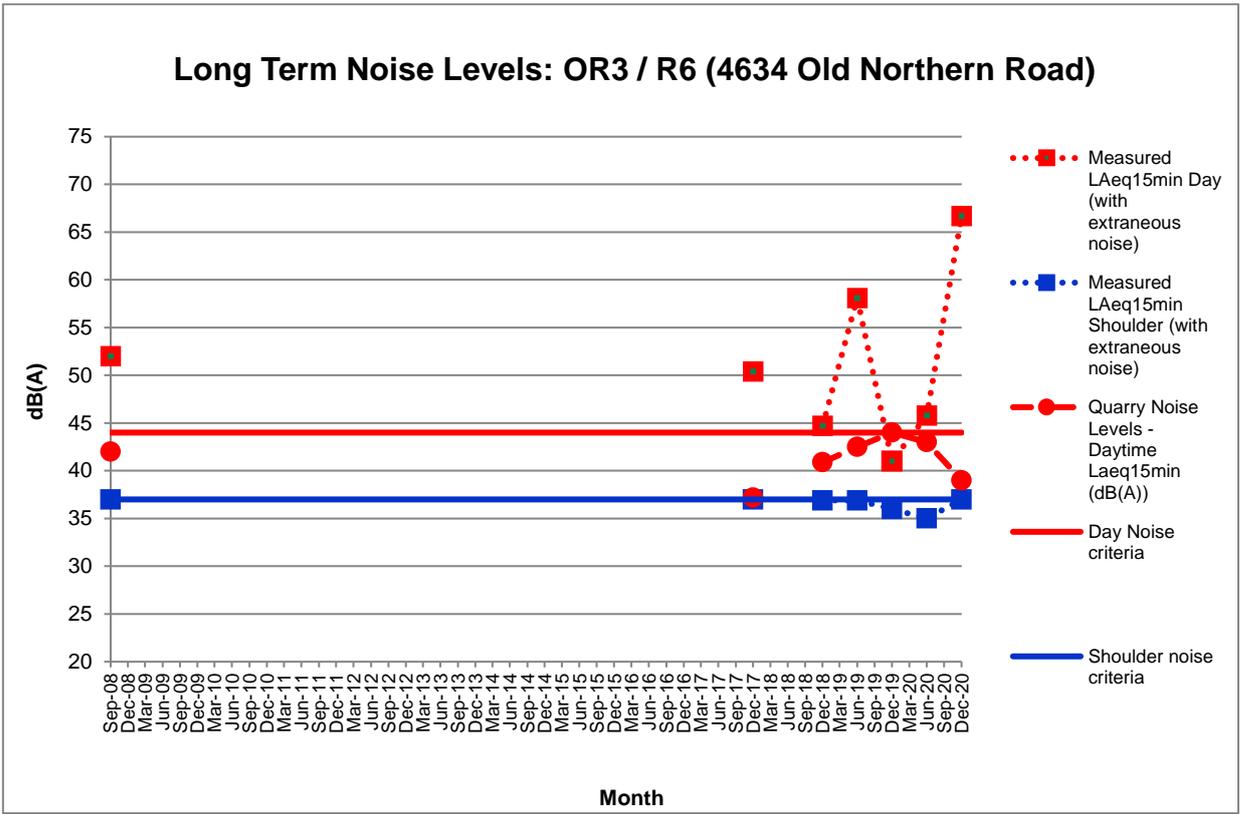
Chart 3 - Long term Noise Trend – OR3/R6 (No. 4634 Old Northern Road)

Chart 3 shows long term trend at receiver OR3 (R6) ranging between L_{Aeq15} 37 and 44 dB(A).

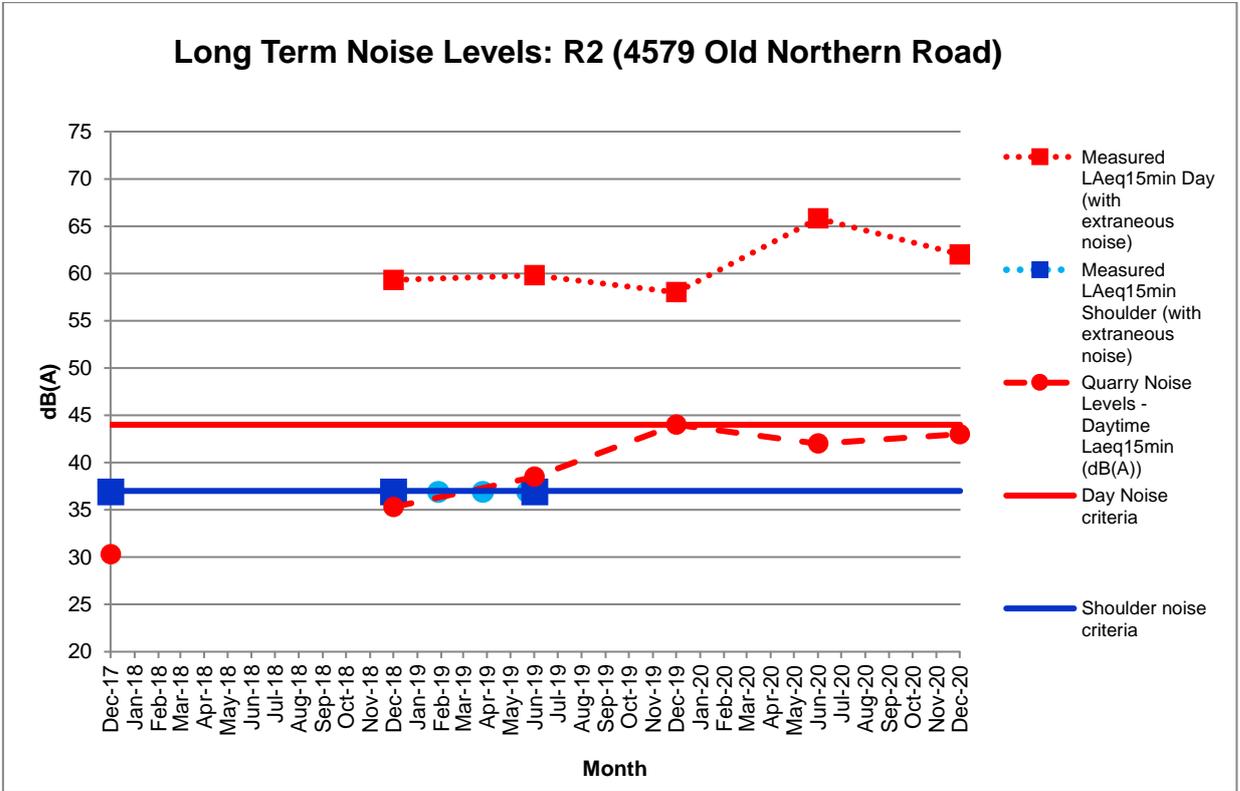
Chart 4 - Long term Noise Trend – R2 (No. 4579 Old Northern Road)

Charts 4 to 6 inclusive display an increasing trend in quarry noise levels at receivers R2, R3, R4 and R5, from December 2018 to date, peaking at L_{Aeq15} 44 dB(A).

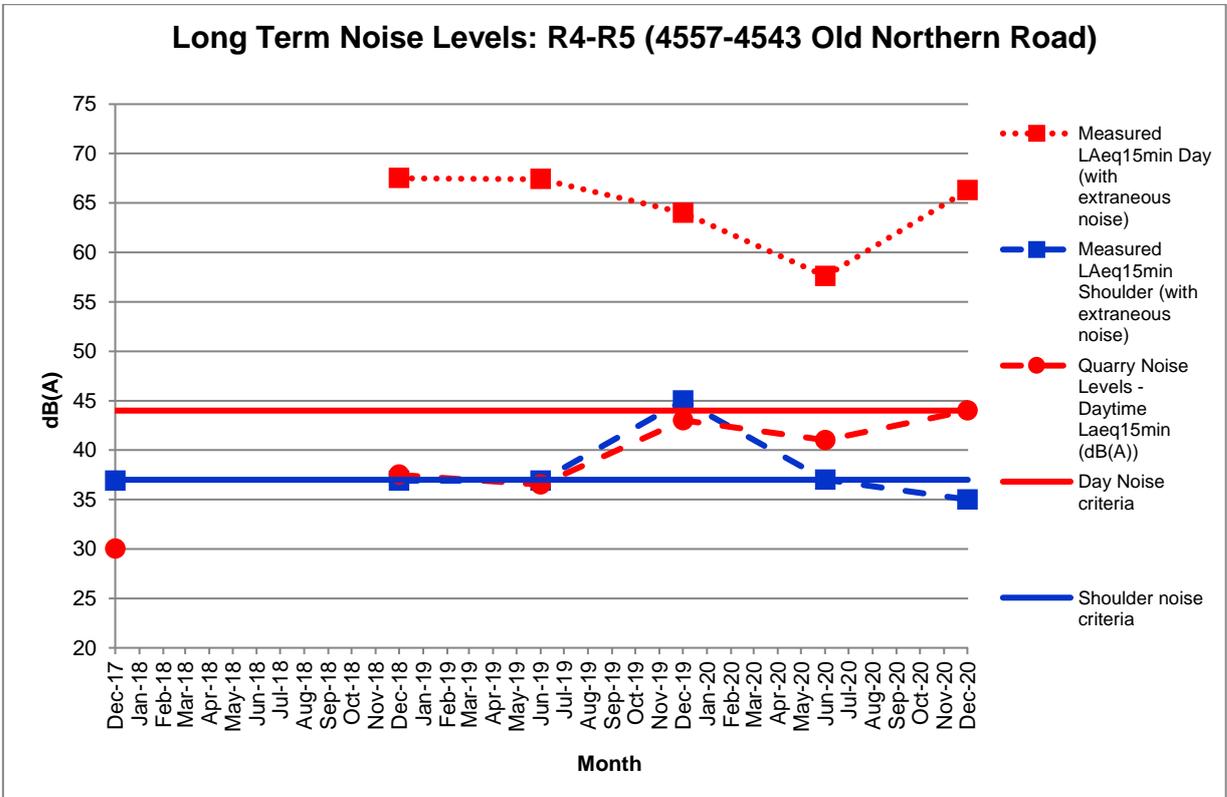
Chart 6 - Long term Noise Trend – R4/R5 (No. 4634 Old Northern Road)

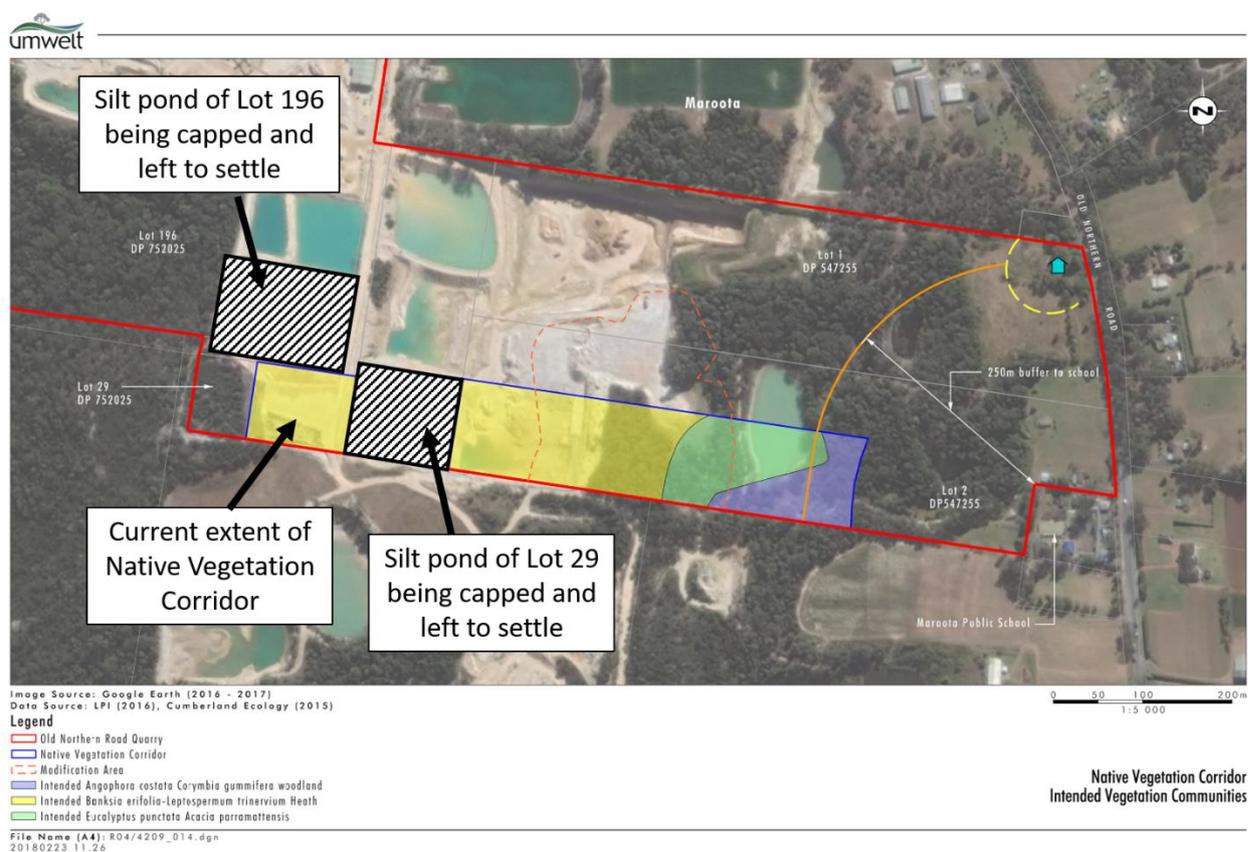
Figure 2: Locations of capped and settling silt ponds, in preparation for future rehabilitation/revegetation.

The locations of the capped and settling silt ponds are shown in Figure 2 below.

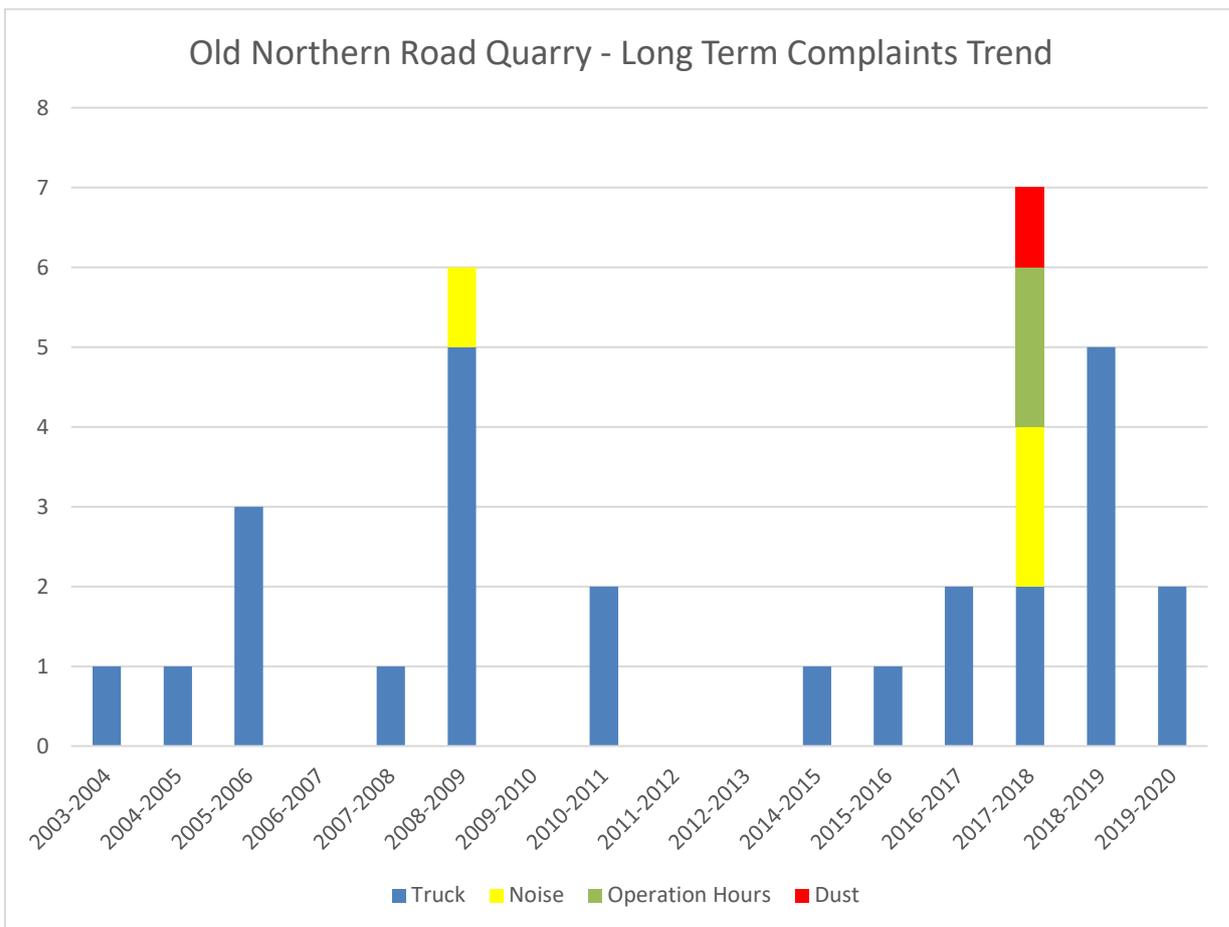
Chart 7 - Long term complaints monitoring data.

Long term complaints monitoring data commencing since the 2003 – 2004 monitoring period is depicted in Chart 7 below. It must be noted that complaints were recorded for the Old Northern Road and Haerses Road quarries combined from the 2006 – 2007 to 2017 – 2018 monitoring periods, with complaints recorded separately for individual quarries from hereon.
